CRITERIUM[®] LALANCETTE ENGINEERS

An Independently Owned and Operated S Corp
230 N Main St Ste 4
Rutland, VT 05701-2416
TEL 802 747-4535 / FAX 802 775-2307
www.criterium-lalancette.com

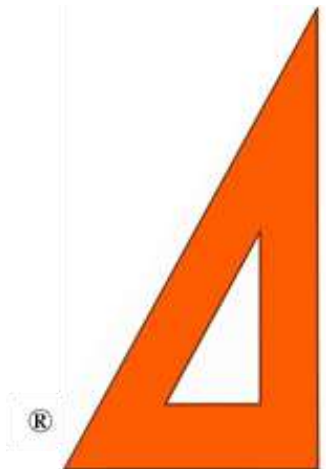
*BUILDING INSPECTIONS
ANALYSIS & DIAGNOSTICS
RESERVE STUDIES
CAPITAL NEEDS ASSESSMENTS
ENVIRONMENTAL TESTING*

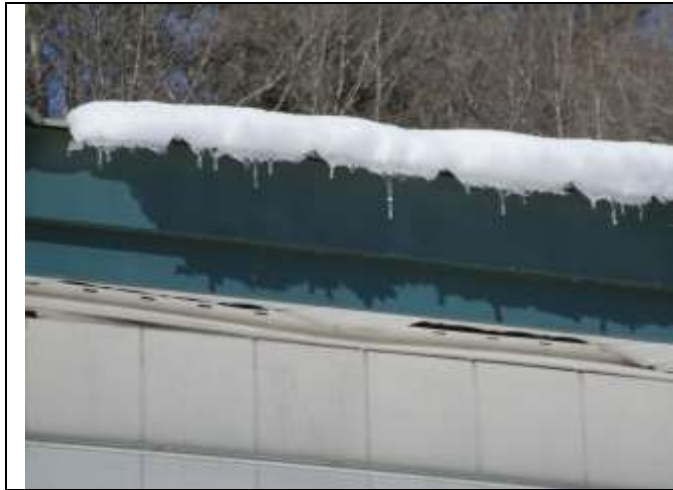
Location:
347 Depot St
Jamaica, VT

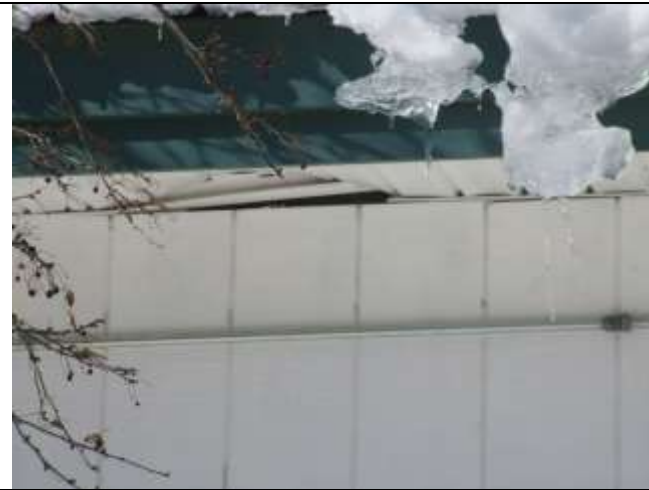
Location:
347 Depot St
Jamaica, VT

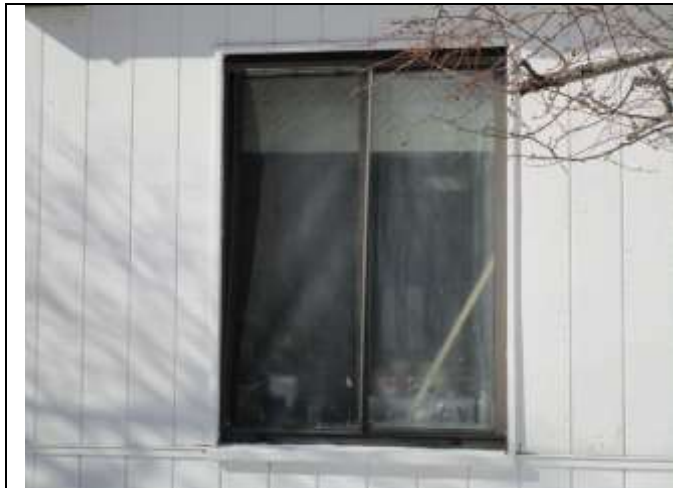
Location:
347 Depot St
Jamaica, VT

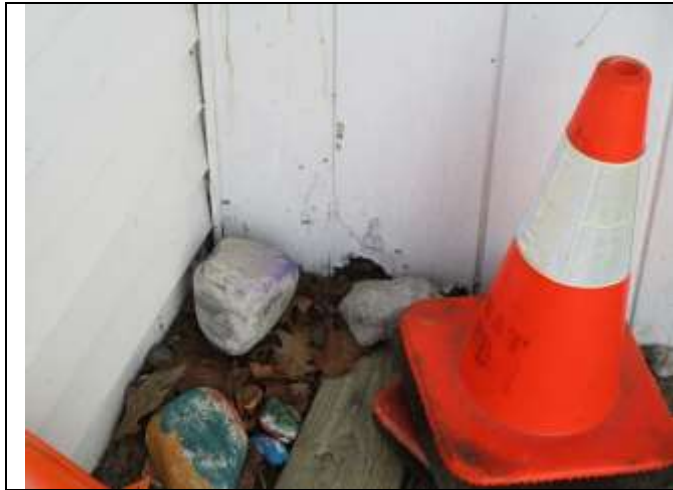
Location:
347 Depot St
Jamaica, VT

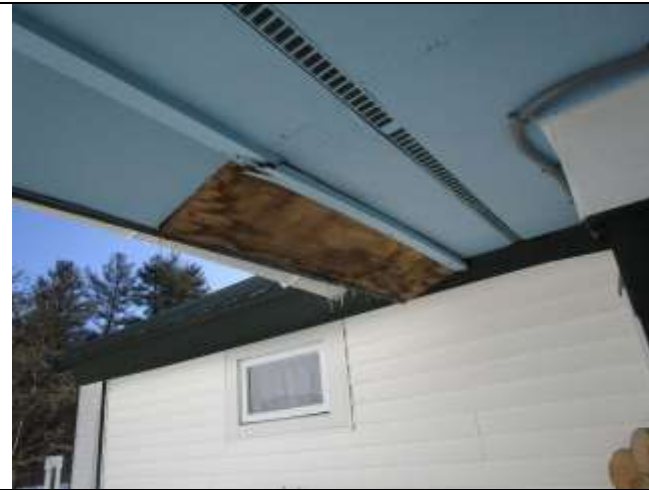
Location:
347 Depot St
Jamaica, VT

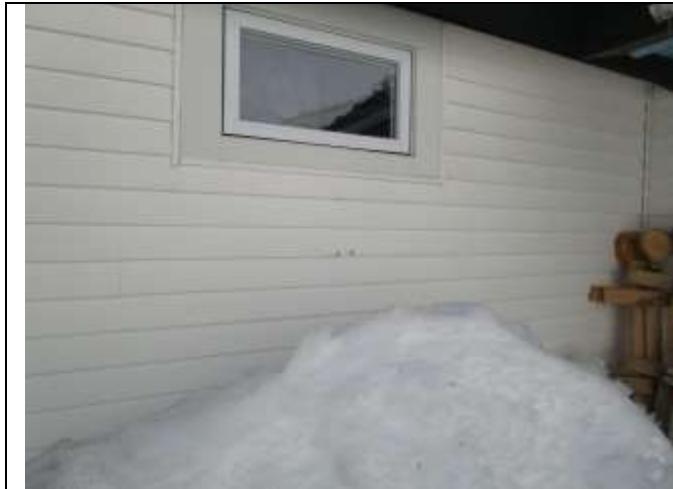
Location:
347 Depot St
Jamaica, VT

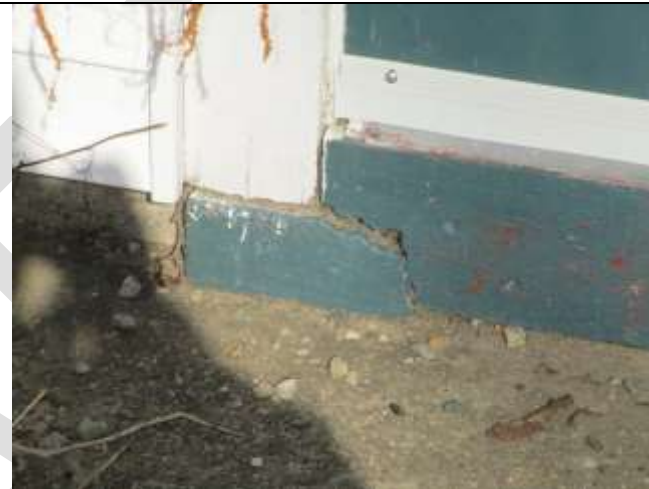
Location:
347 Depot St
Jamaica, VT

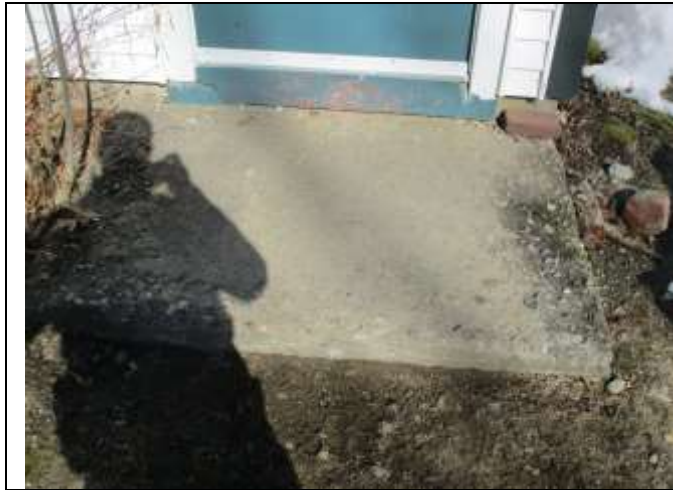
Location:
347 Depot St
Jamaica, VT

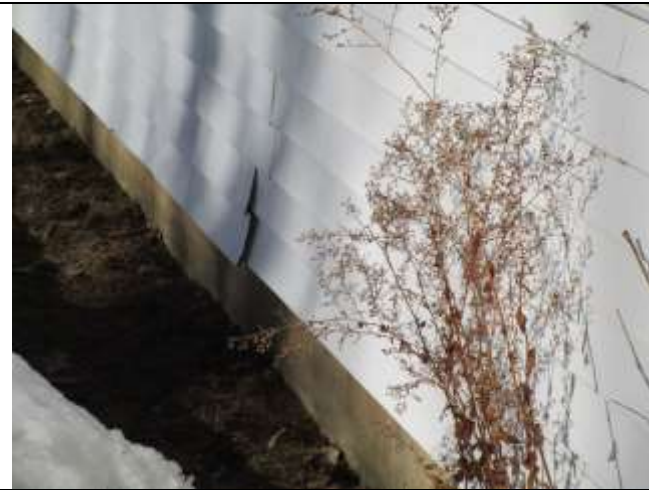
Location:
347 Depot St
Jamaica, VT

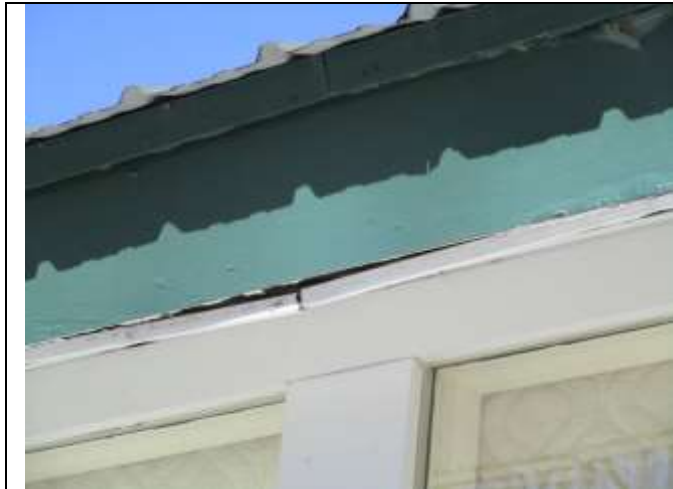
Location:
347 Depot St
Jamaica, VT

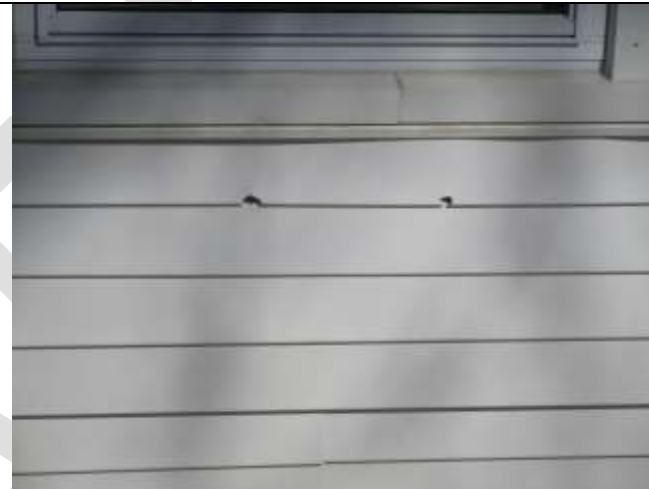
Location:
347 Depot St
Jamaica, VT

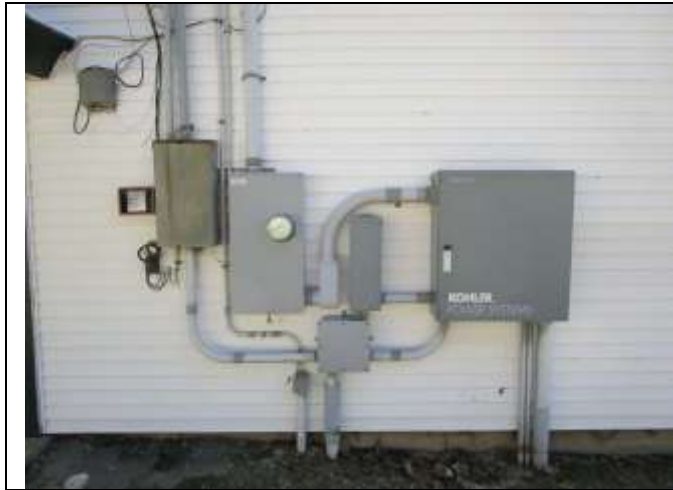
Location:
347 Depot St
Jamaica, VT

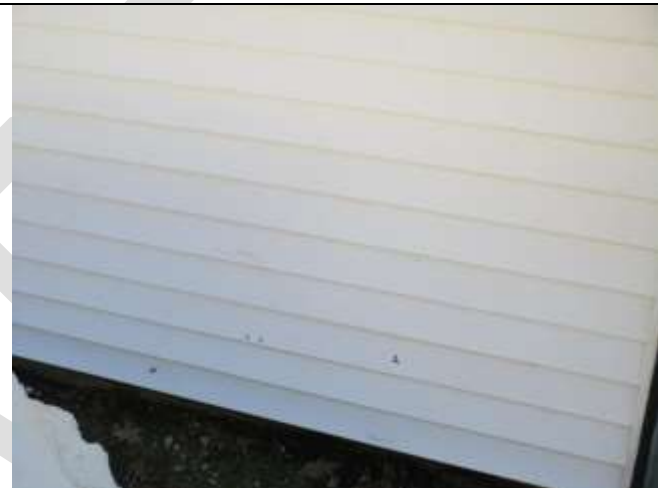
Location:
347 Depot St
Jamaica, VT

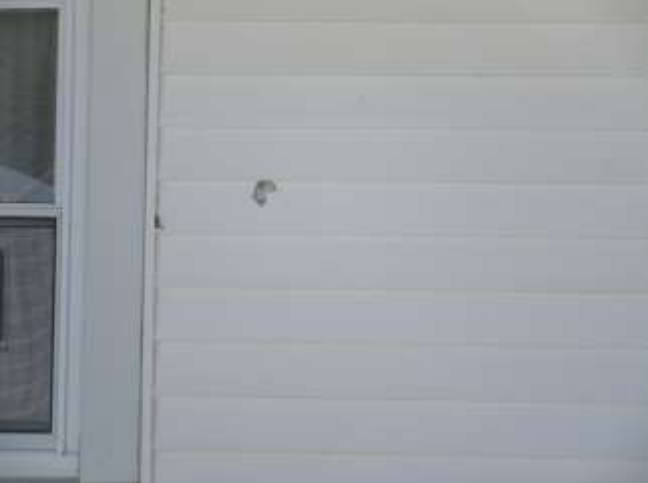
<p><u>Location:</u> 347 Depot St Jamaica, VT</p> <p><u>Photo Taken By:</u> Richard Lalancette, P.E.</p> <p><u>IMG:</u> 154</p> <p><u>Description:</u> Damaged vinyl siding</p>

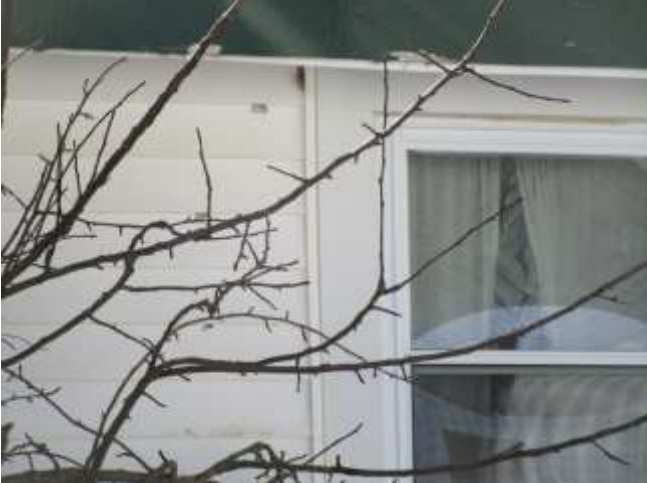
<p><u>Location:</u> 347 Depot St Jamaica, VT</p> <p><u>Photo Taken By:</u> Richard Lalancette, P.E.</p> <p><u>IMG:</u> 155</p> <p><u>Description:</u> Damaged vinyl siding</p>

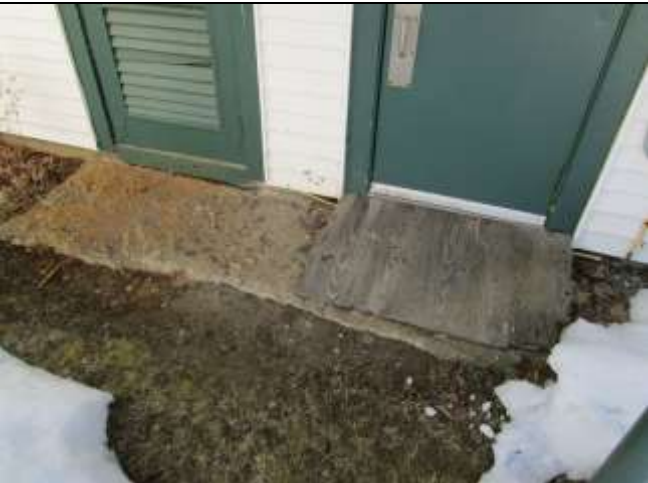
<p><u>Location:</u> 347 Depot St Jamaica, VT</p> <p><u>Photo Taken By:</u> Richard Lalancette, P.E.</p> <p><u>IMG:</u> 156</p> <p><u>Description:</u> Deteriorated entry platform at door to old furnace room</p>

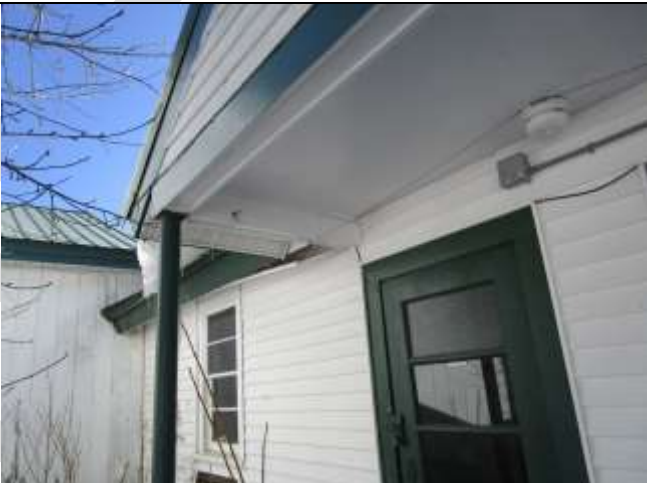
<p><u>Location:</u> 347 Depot St Jamaica, VT</p> <p><u>Photo Taken By:</u> Richard Lalancette, P.E.</p> <p><u>IMG:</u> 157</p> <p><u>Description:</u> Damaged soffit trim at rear of building</p>

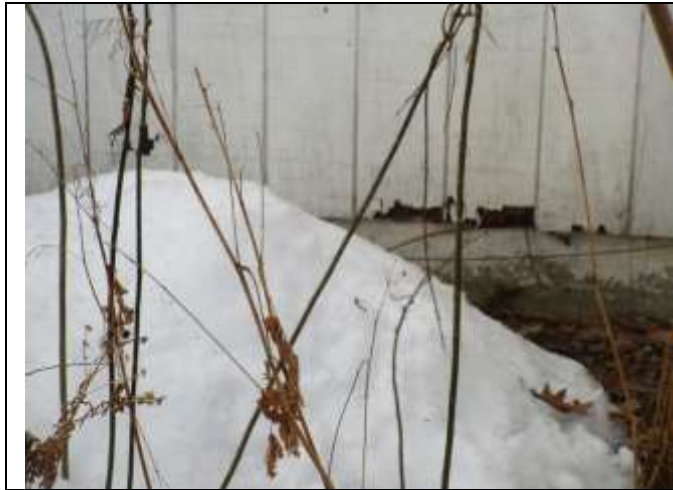
Location:
347 Depot St
Jamaica, VT

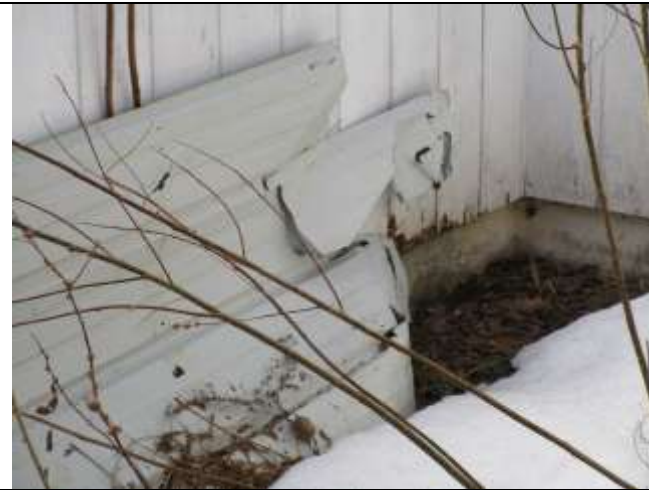
Location:
347 Depot St
Jamaica, VT

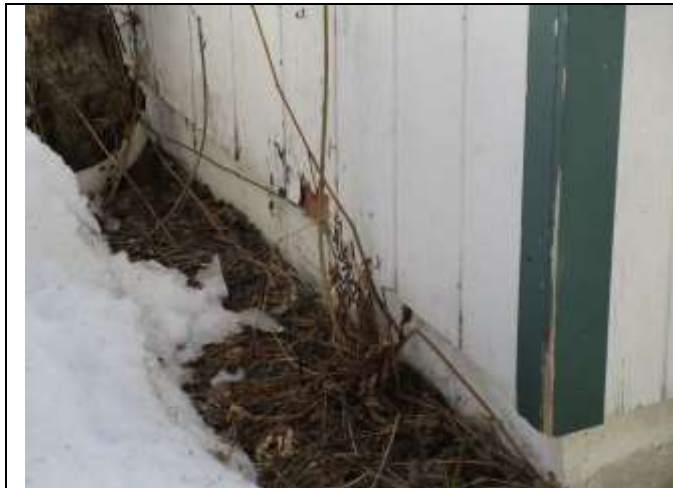
Location:
347 Depot St
Jamaica, VT

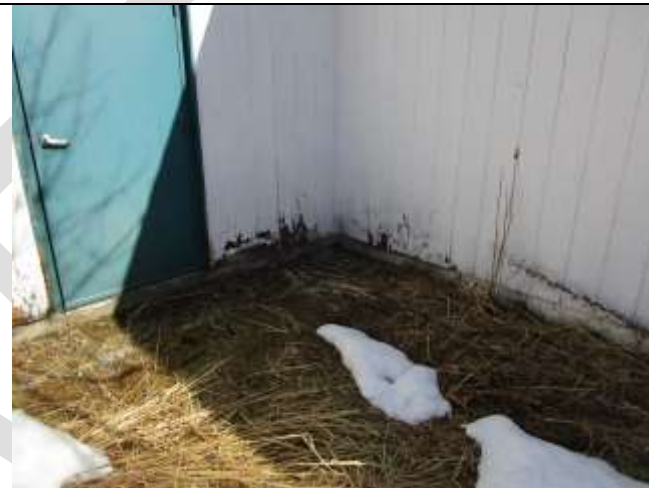
Location:
347 Depot St
Jamaica, VT

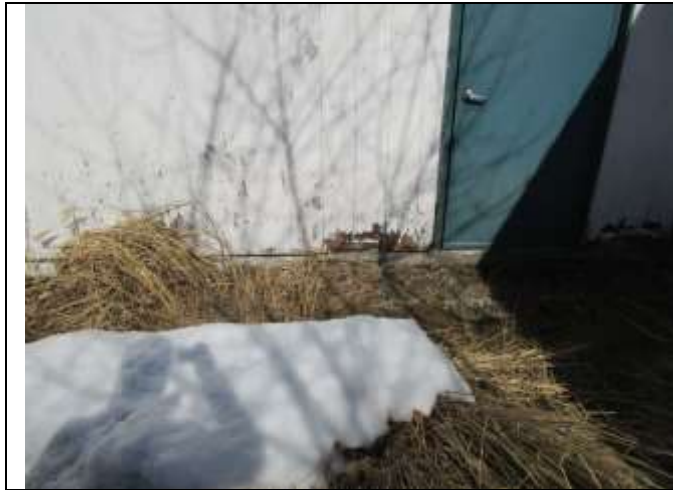
Location:
347 Depot St
Jamaica, VT

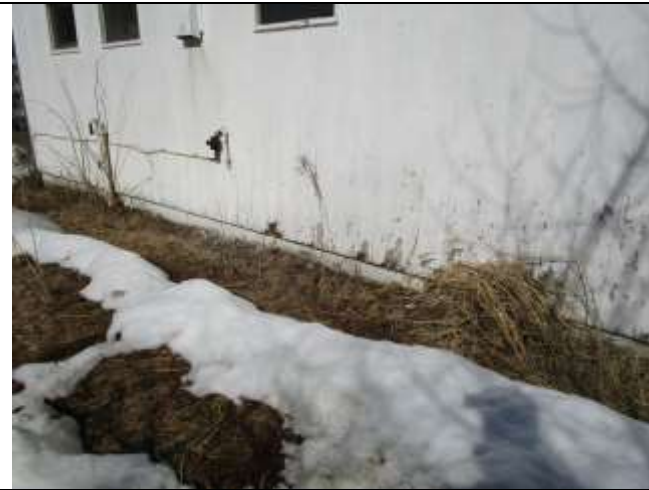
Location:
347 Depot St
Jamaica, VT

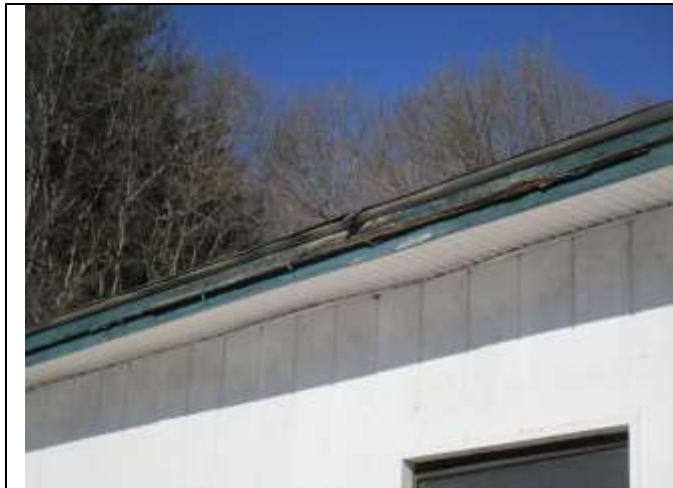
Location:
347 Depot St
Jamaica, VT

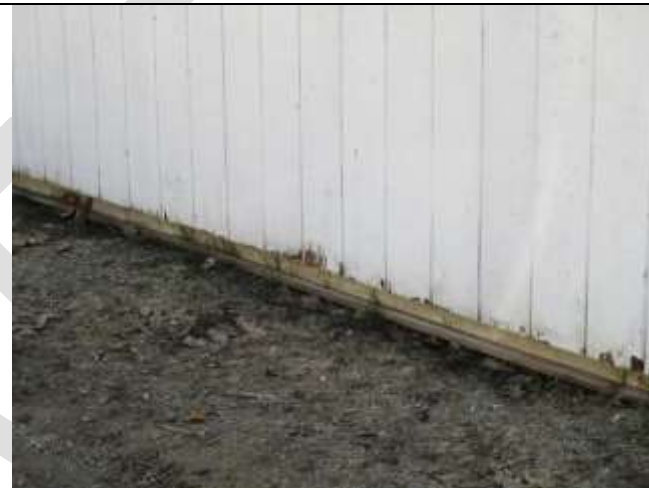
Location:
347 Depot St
Jamaica, VT

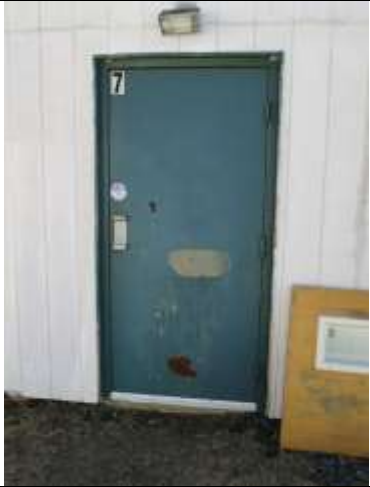
<p><u>Location:</u> 347 Depot St Jamaica, VT</p> <p><u>Photo Taken By:</u> Richard Lalancette, P.E.</p> <p><u>IMG:</u> 166</p> <p><u>Description:</u> Deteriorated exterior door</p>

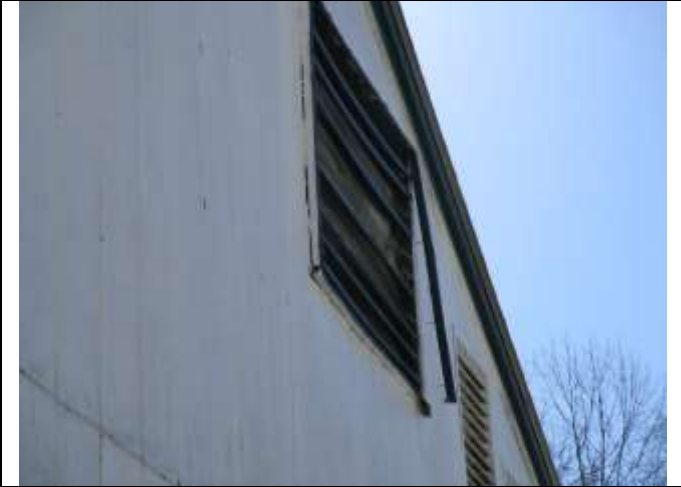
<p><u>Location:</u> 347 Depot St Jamaica, VT</p> <p><u>Photo Taken By:</u> Richard Lalancette, P.E.</p> <p><u>IMG:</u> 167</p> <p><u>Description:</u> Deteriorated louvre at rear of building</p>

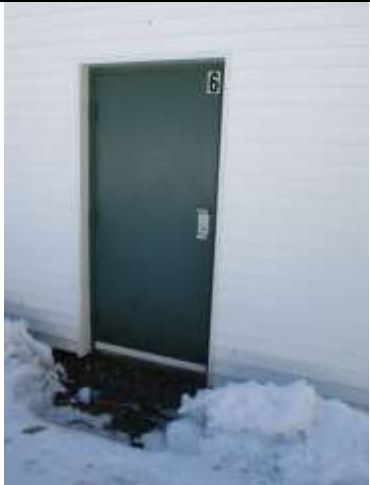
<p><u>Location:</u> 347 Depot St Jamaica, VT</p> <p><u>Photo Taken By:</u> Richard Lalancette, P.E.</p> <p><u>IMG:</u> 168</p> <p><u>Description:</u> Deteriorated exterior door</p>

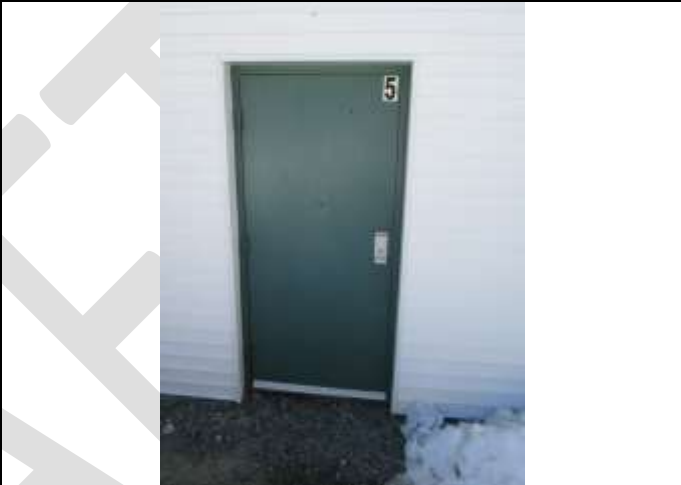
<p><u>Location:</u> 347 Depot St Jamaica, VT</p> <p><u>Photo Taken By:</u> Richard Lalancette, P.E.</p> <p><u>IMG:</u> 169</p> <p><u>Description:</u> Deteriorated exterior door</p>

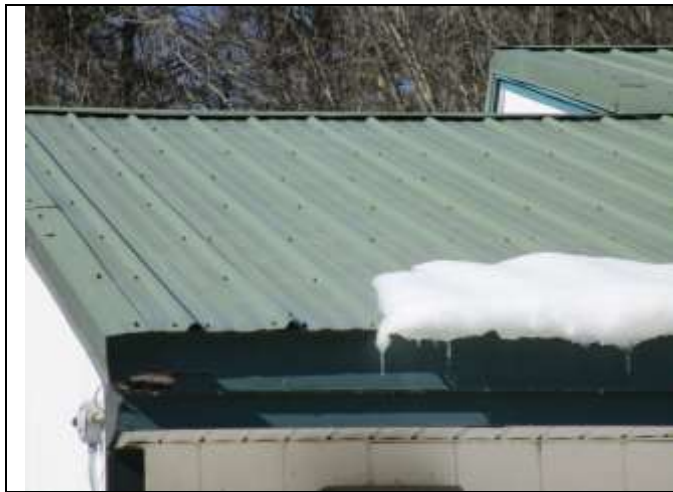
Location:
347 Depot St
Jamaica, VT

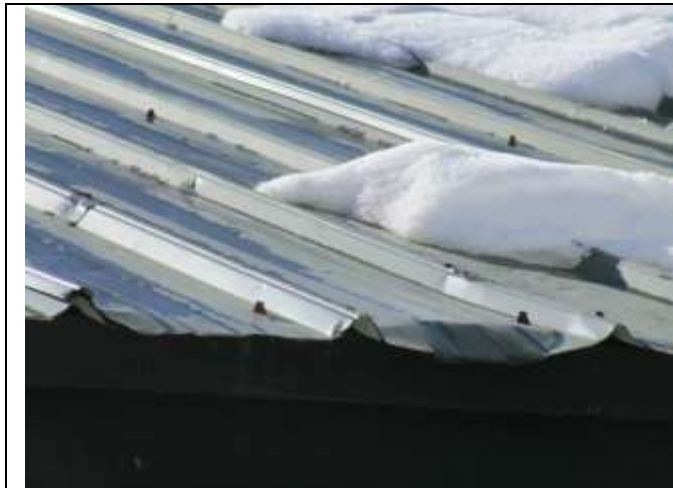
Location:
347 Depot St
Jamaica, VT

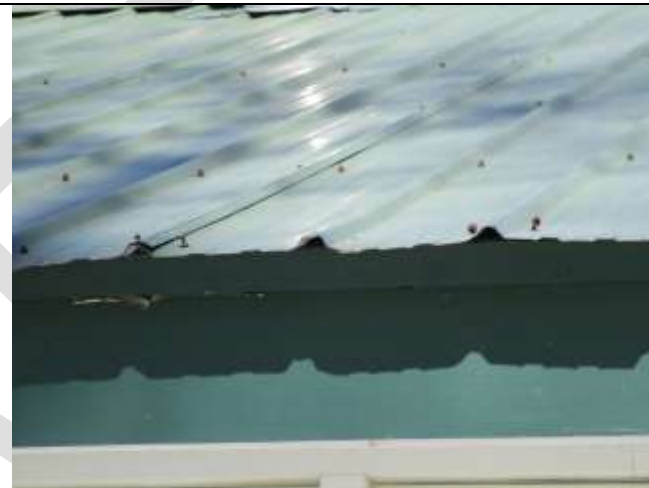
Location:
347 Depot St
Jamaica, VT

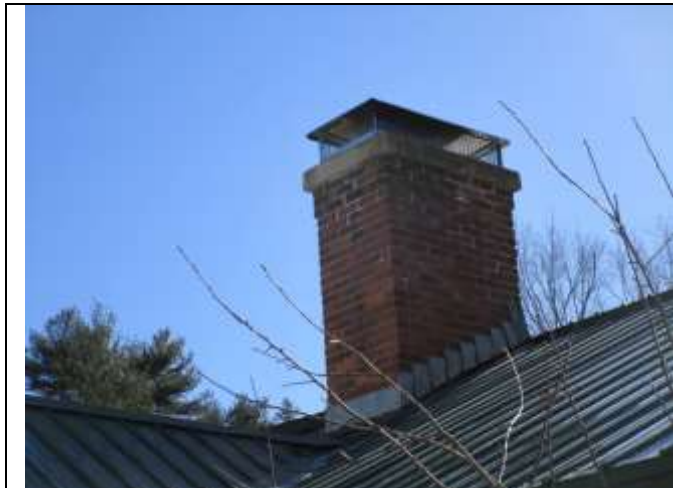
Location:
347 Depot St
Jamaica, VT

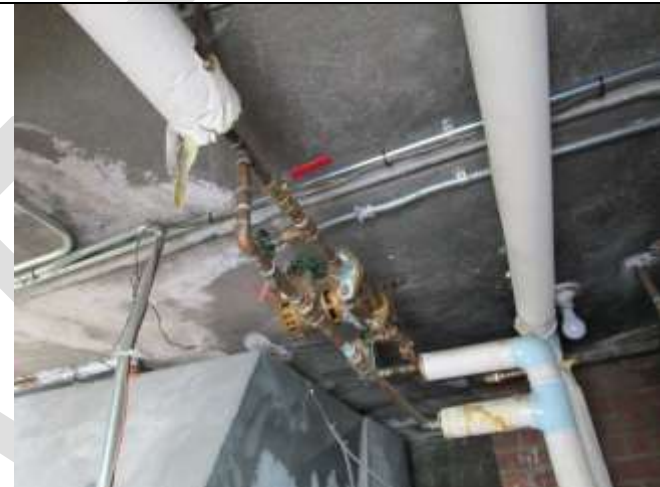
Location:
347 Depot St
Jamaica, VT

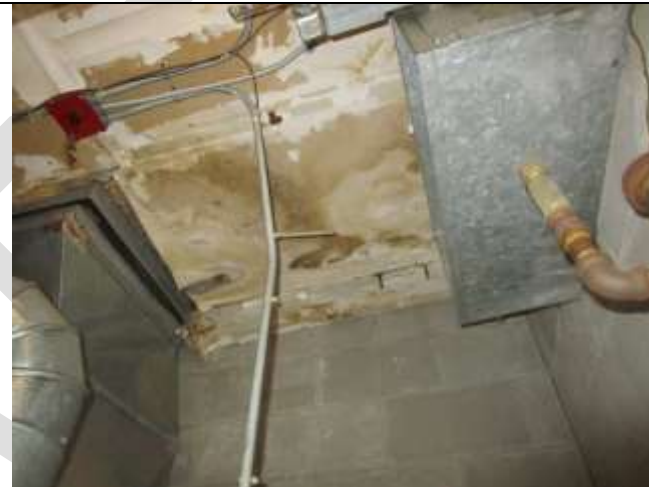
Location:
347 Depot St
Jamaica, VT

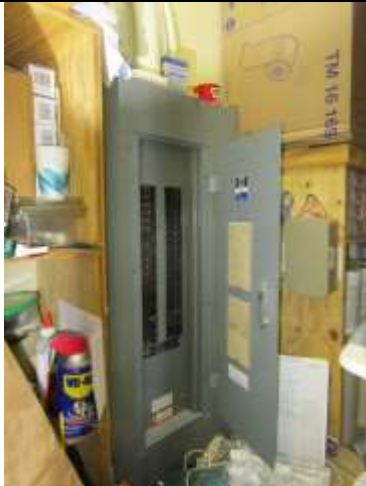
Location:
347 Depot St
Jamaica, VT

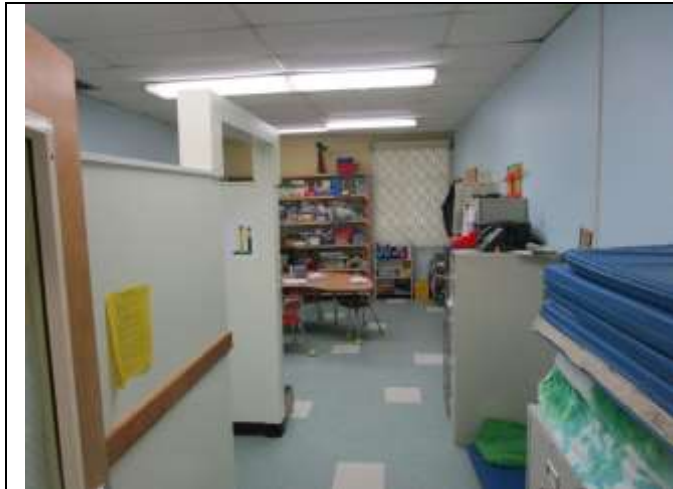
Location:
347 Depot St
Jamaica, VT
