FACILITY CONDITION ASSESSMENT

**Vermont Agency of Education_FCA Phase Two
1 National Life Drive, Davis 5
Montpelier, VT 05620-2501**

May 22, 2023

**JAMAICA VILLAGE SCHOOL - Main Building (PS149-SU031)
347 Depot Street
Jamaica VT, 05343**

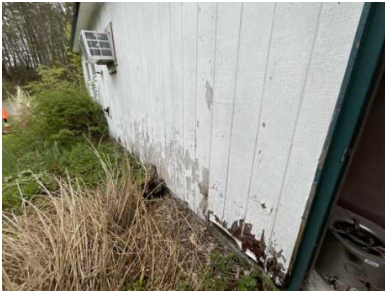
Exterior Walls in Poor condition.

Wood Siding
JAMAICA VILLAGE SCHOOL - Main Building Exterior

Exterior, T1- 11 siding is deteriorating and needs replacement - AssetCALC ID: 6087897

Uniformat Code: B2010
Recommendation: **Replace in 2023**
Priority Score: **89.9**
Plan Type: Performance/Integrity
Cost Estimate: \$30,000

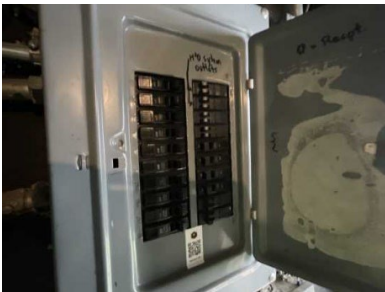
Supplemental Components in Poor condition.

Load Center, Single Phase Residential 120/240 V
JAMAICA VILLAGE SCHOOL - Main Building Mechanical Room

Load center past estimated useful life - AssetCALC ID: 6087903

Uniformat Code: D5020
Recommendation: **Replace in 2023**
Priority Score: **87.9**
Plan Type: Performance/Integrity
Cost Estimate: \$5,700

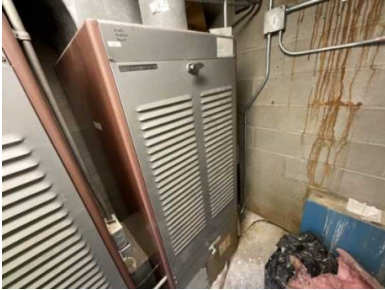
Furnace in Poor condition.

Oil
JAMAICA VILLAGE SCHOOL - Main Building Mechanical Room

Furnaces have passed recommended useful life - AssetCALC ID: 6087889

Uniformat Code: D3020
Recommendation: **Replace in 2023**
Priority Score: **86.9**
Plan Type: Performance/Integrity
Cost Estimate: \$40,000

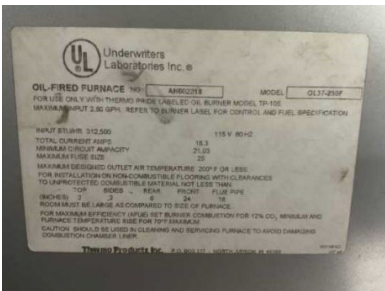
Furnace in Poor condition.

Oil
JAMAICA VILLAGE SCHOOL - Main Building Mechanical Room

Furnaces have passed recommended useful life - AssetCALC ID: 6087887

Uniformat Code: D3020
Recommendation: **Replace in 2023**
Priority Score: **86.9**
Plan Type: Performance/Integrity
Cost Estimate: \$17,500

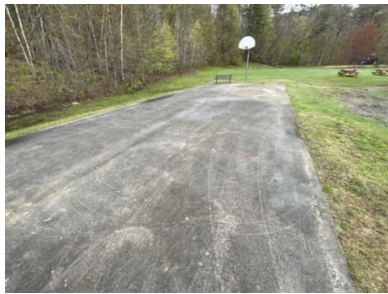
Athletic Surfaces & Courts in Poor condition.

Basketball/General, Asphalt Pavement
JAMAICA VILLAGE SCHOOL - Main Building Site

Faded lines - AssetCALC ID: 6175546

Uniformat Code: G2050
Recommendation: **Seal & Stripe in 2023**
Priority Score: **82.9**
Plan Type: Performance/Integrity
Cost Estimate: \$700

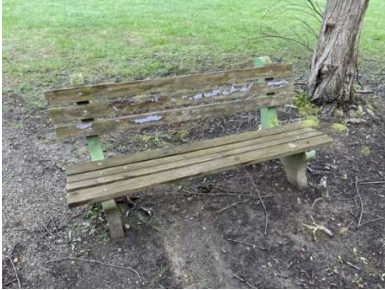
Park Bench in Poor condition.

Precast Concrete
 JAMAICA VILLAGE SCHOOL - Main Building Site

Bench is broken and past useful life - AssetCALC ID: 6087888

Uniformat Code: G2060
 Recommendation: **Replace in 2023**
 Priority Score: **81.9**
 Plan Type: Performance/Integrity
 Cost Estimate: \$2,000
 \$\$\$\$

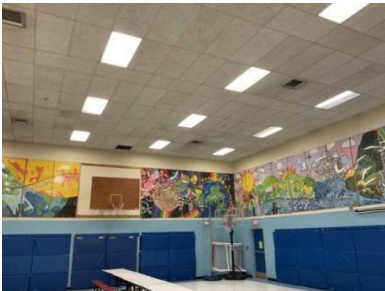
Suspended Ceilings in Poor condition.

Acoustical Tile Fiberglass
 JAMAICA VILLAGE SCHOOL - Main Building Gymnasium

Ceiling tiles look stained and worn. - AssetCALC ID: 6087904

Uniformat Code: C1070
 Recommendation: **Replace in 2023**
 Priority Score: **81.9**
 Plan Type: Performance/Integrity
 Cost Estimate: \$15,400
 \$\$\$\$

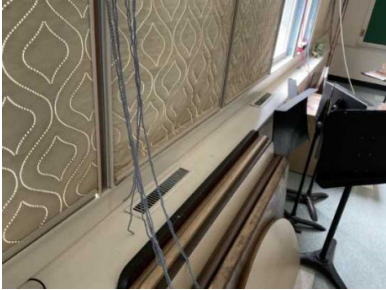
HVAC System in Poor condition.

Ductwork, Medium Density
JAMAICA VILLAGE SCHOOL - Main Building Throughout building

Ductwork is past useful life - AssetCALC ID: 6087900

Recommendation: **Replace in 2023**
