FACILITY CONDITION ASSESSMENT

**Vermont Agency of Education_FCA Phase Two
1 National Life Drive, Davis 5
Montpelier, VT 05620-2501**

May 22, 2023

**JAMAICA VILLAGE SCHOOL - Main Building (PS149-SU031)
347 Depot Street
Jamaica VT, 05343**

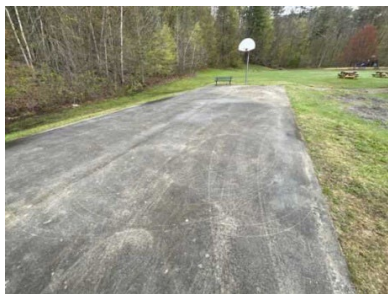
Athletic Surfaces & Courts in Poor condition.

Basketball/General, Asphalt Pavement
 JAMAICA VILLAGE SCHOOL - Main Building Site

Faded lines - AssetCALC ID: 6175546

Uniformat Code: G2050
 Recommendation: **Seal & Stripe in 2023**
 Priority Score: **82.9**
 Plan Type: Performance/Integrity
 Cost Estimate: \$700

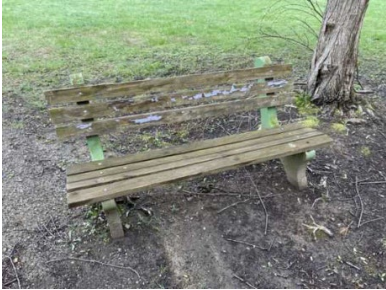
Park Bench in Poor condition.

Precast Concrete
 JAMAICA VILLAGE SCHOOL - Main Building Site

Bench is broken and past useful life - AssetCALC ID: 6087888

Uniformat Code: G2060
 Recommendation: **Replace in 2023**
 Priority Score: **81.9**
 Plan Type: Performance/Integrity
 Cost Estimate: \$2,000
 \$\$\$\$

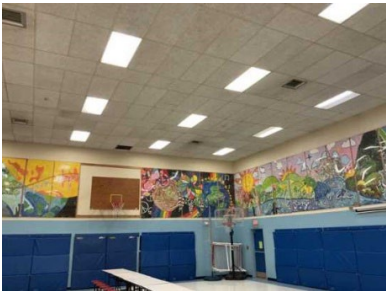
Suspended Ceilings in Poor condition.

Acoustical Tile Fiberglass
 JAMAICA VILLAGE SCHOOL - Main Building Gymnasium

Ceiling tiles look stained and worn. - AssetCALC ID: 6087904

Uniformat Code: C1070
 Recommendation: **Replace in 2023**
 Priority Score: **81.9**
 Plan Type: Performance/Integrity
 Cost Estimate: \$15,400
 \$\$\$\$

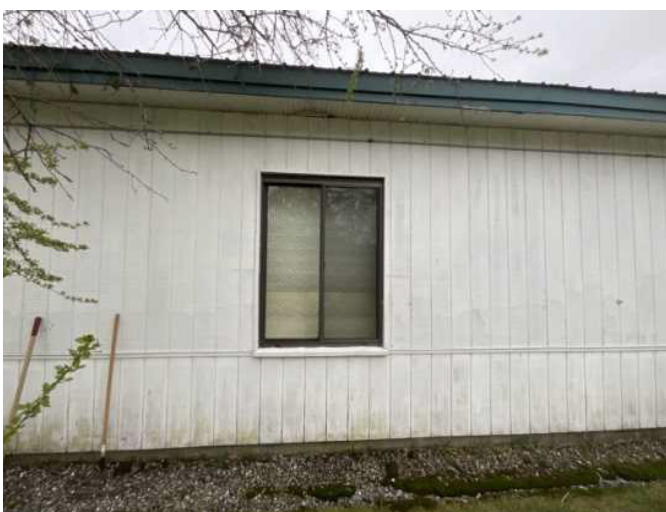
5 - BUILDING FACADE WOOD SIDING

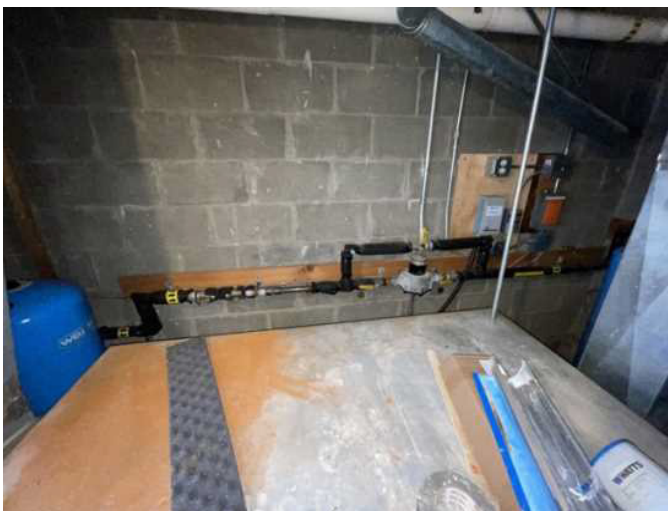
15 - PLUMBING SYSTEM FROM WELL

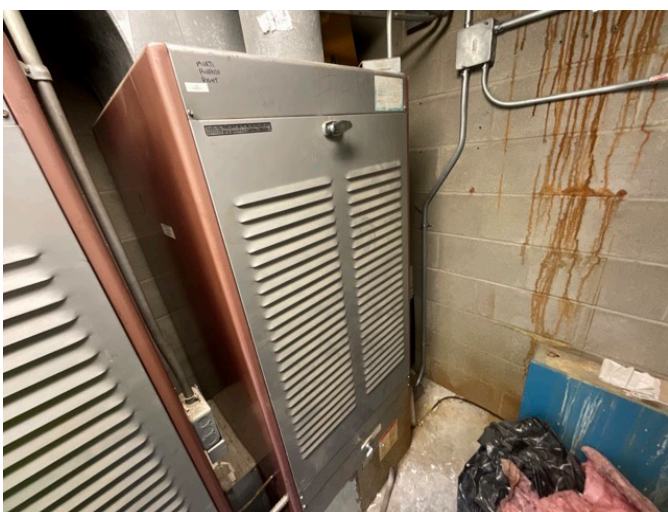
17 - OIL FIRED FURNACE UNIT

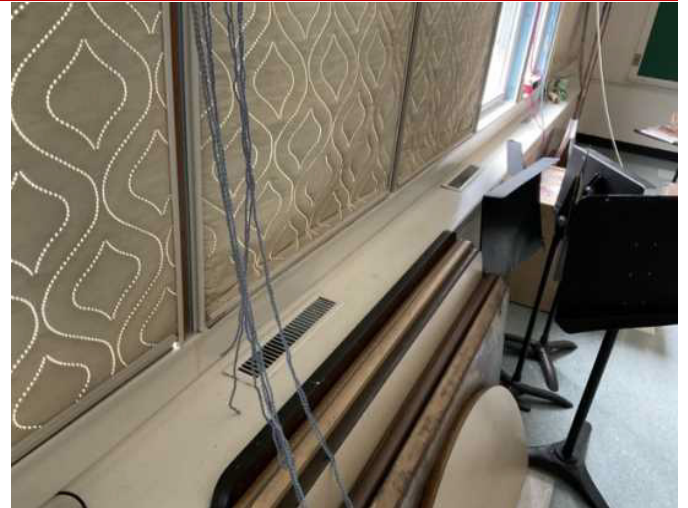
20 - DUCT WORK BEHIND CLASSROOM SHELF
